# BUILDING ENVELOPE FAILURE

### CASE STUDY: SHIPYARD CONDOMINIUMS

Shipyards Village Buildings A and B are five story, forty unit beach front condominiums located in Pawleys Island, SC. Repairs totaling approximately \$8.5 million were undertaken at both buildings, including concrete repair and replacement, cathodic protection (CP), coatings and fenestration replacement. The structural system includes prestressed hollow-core panels (PHCP) supported by load bearing concrete masonry walls and reinforced concrete beams. Corrosion-related distress was observed at portions of the exterior PHCP and beams supporting the panels, and reinforced concrete slab edges supporting windows. A study was conducted to determine the contamination levels and distress of representative components with respect to the different areas of the building

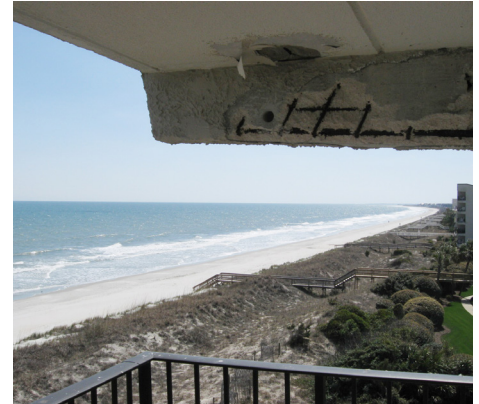
Corrosion distress at beam and hollow-core panel

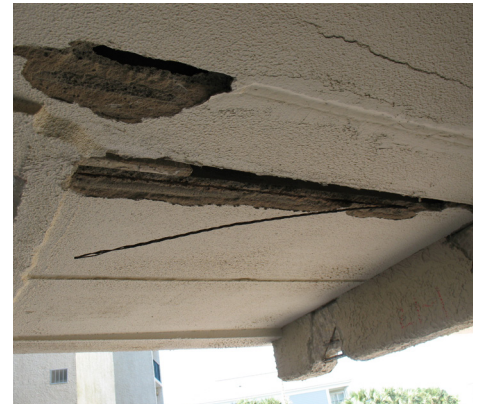
Corrosion distress at hollow-core panels

In review of the data, distress patterns, general costs and complexity for intricate repairs on the thin-section PHCP with additional long-term preservation strategy (CP), it was decided to remove and replace panels in areas with heightened observed distress (ocean-side balcony panels and courtyard-side panels in the central portion of the condominiums) and implement limited repairs and a preventative protection strategy at remaining panels with a thermal spray CP system. Costs associated with removal and replacement of cantilever beams with variable amounts of distress at walkway and balcony locations and slab edges supporting curtain walls on the ocean-side were also favorable compared to widespread implementation of individual concrete repairs and CP strategy at these areas. Ocean-side haunches were patched and galvanically protected. Although coatings alone are generally not effective as long term solutions to on-going corrosion in coastal environments, protective coatings were used to compliment the cathodic protection system performance and provide architectural finishes.

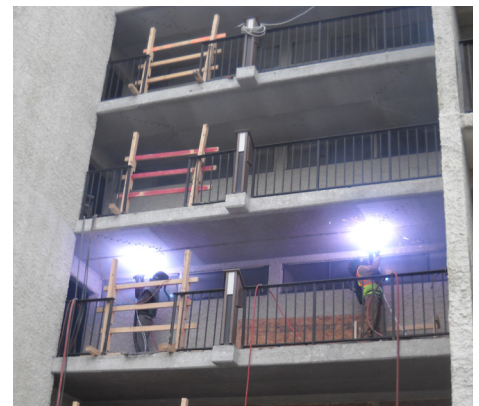
Thermal spray cathodic protection being applied to walkway hollow-core panels with contamination but limited distress

concrete haunches supporting ocean-side masonry walls with minimal outward distress were protected with thermal spray CP and a breathable aesthetic topcoat. CP monitoring stations were installed at representative locations. Ocean-front PHCP and land-side PHCP with increased oceanic wind exposure, contamination and distress, and associated cantilever beams were removed and replaced with a high-performance lightweight concrete mixture. The mixture was designed with weight similar to the replaced PHCP, and resistance to chloride ingress, cracking and other deterioration mechanisms. New slabs were keyed into the existing masonry walls or supported on cantilever beams on the ocean-side balconies, depending on existing configuration. The land-side walkway sections were cast integrally with replaced cantilever beams without control joints. Because some existing beams did not meet current live load requirements, supplemental reinforcing or pilasters were installed to increase capacity. Cathodic prevention point anodes were installed at interfaces to deter incipient corrosion. Most concrete and repair work was conducted in winter, requiring close attention to placement and curing. Slabs were sloped to promote drainage and components were coated.

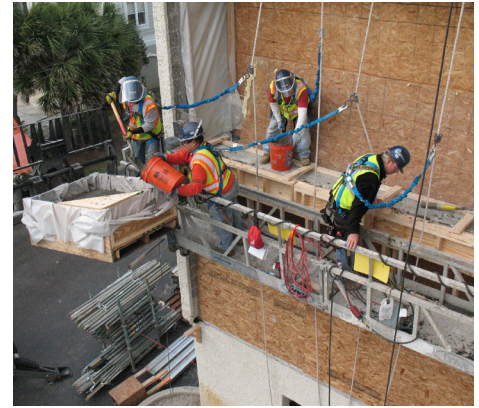
Slab edge replacement prior to window installation

to select the economical repair methods. Corrosion of embedded reinforcing and prestressing steel was the result of elevated chloride levels in the concrete. Ocean-front slab edges were replaced with pre-packaged repair materials prior to new window installation. Land-side PHCP and ocean-side reinforced

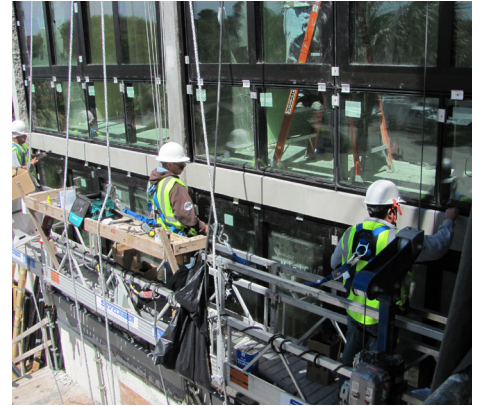
Curtainwall window installation

Sliding glass doors and windows were beyond useful service life. Demising walls were installed so that slab edges could be replaced and new impact resistant sliding doors and curtain wall fenestration could be installed. Curbs were installed at thresholds and new sliding glass doors were installed at all units. Extensive water testing was conducted on new windows and doors to confirm watertightness, especially important in hurricane zones subject to storms and high winds. Handrails, similarly at the end of useful service life, were installed and also included high-performance fluoropolymer coatings.

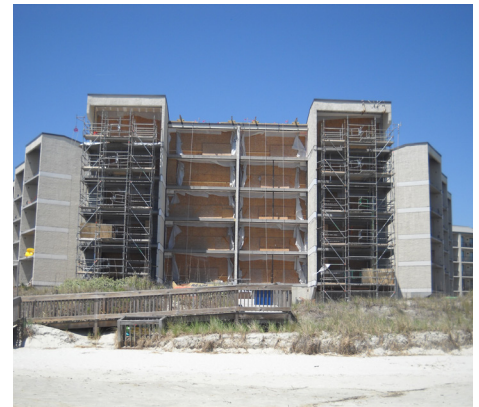
Oceanfront elevation showing balconies with demising walls and scaffolding - scope area included flanking balconies

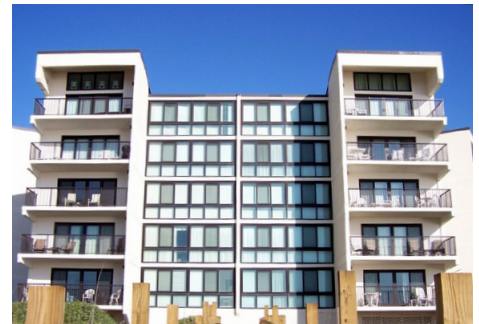
Finished oceanfront elevation showing new balconies, guardrails, windows and doors

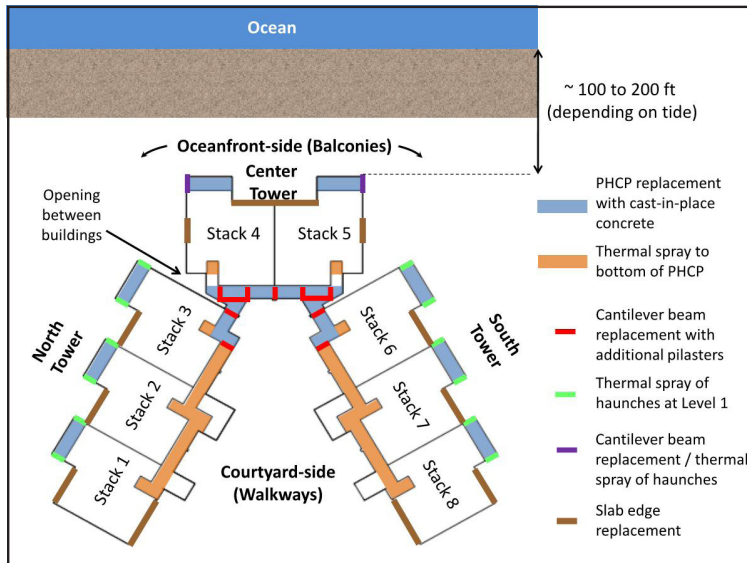
General concrete restoration and preservation methodology (coatings installed at all locations)

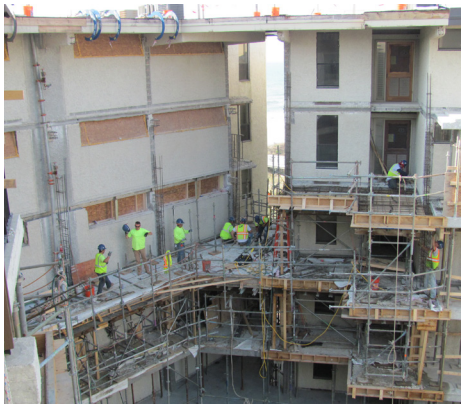
Courtyard window and concrete replacement in progress at area of heightened distress

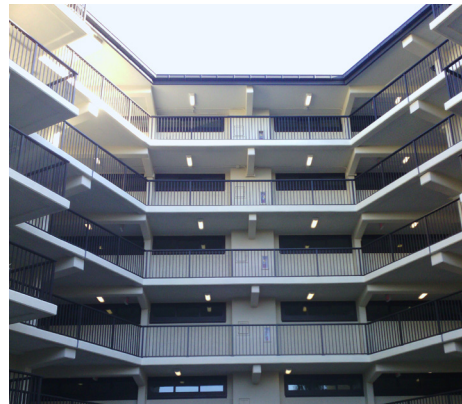
Finished courtyard elevation showing new beams, walkways, guardrails and windows
