CONCRETE REPAIR BULLETIN

July/August 2023
Vol. 36, No. 4

Design for Longevity: A Look Back at Concrete Rehabilitation and Preservation at Shipyard Village Condominiums

by David G. Tepke, Nicholas B. Tribble, and Stephen P. Robinson

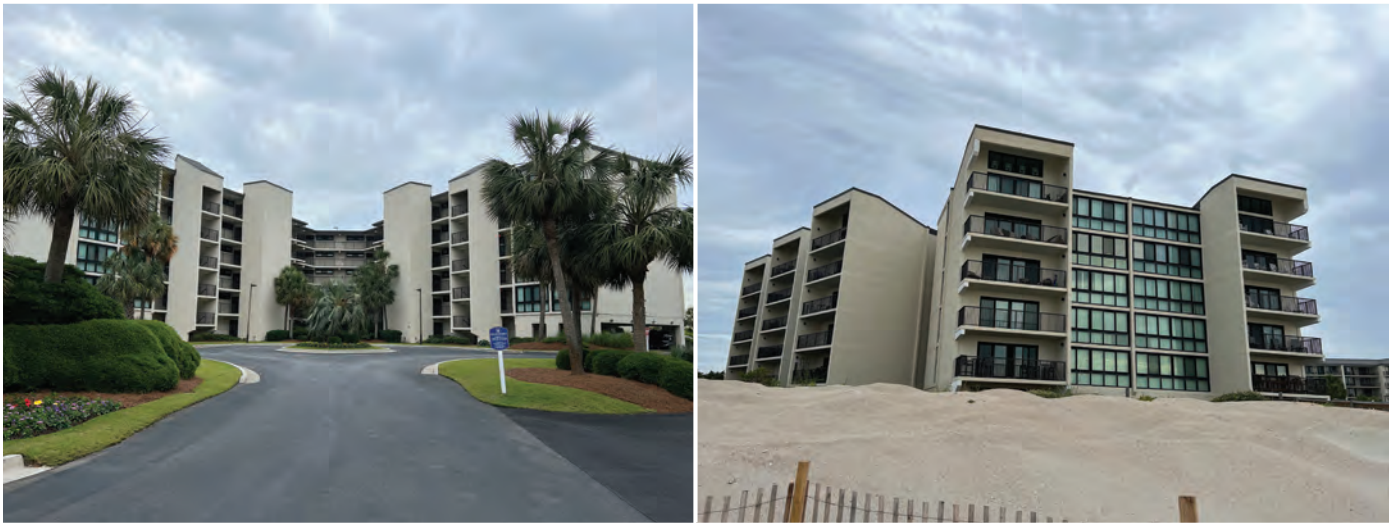
Fig. 1: 2023 photos: courtyard side of Building A (left) and ocean side (right)

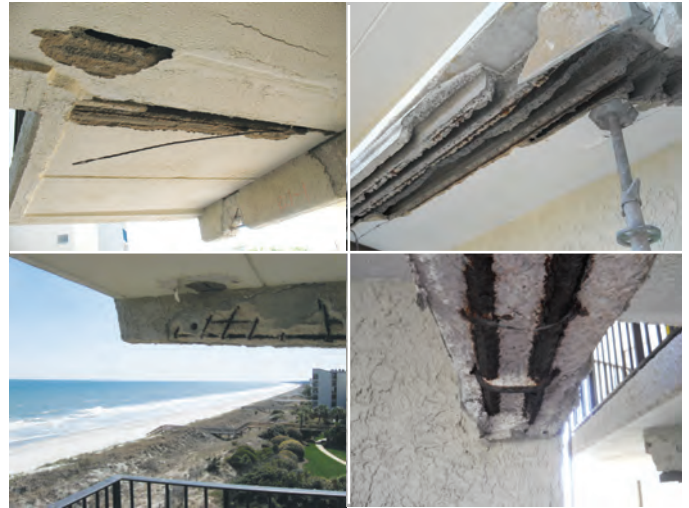
at the level of reinforcing and prestressing steel at various locations, particularly at ocean front locations and at the walkway areas adjacent to the separations between the structures. Areas with high chlorides coincided with areas of visually observed distress in varying quantities. Windy conditions were characteristic of the walkway locations near the building separations, indicating that the increased chloride levels were likely from increased exposure to airborne salts.

Chloride levels at walkway areas away from the separations were mixed; however, reduced amounts of distress were observed in these areas. Distress was also variable at slab edges supporting curtain walls (Fig. 2). Shoring and supplemental supports (Fig. 3) were necessary in some locations to make conditions temporarily safe for occupant use prior to commencement of the repair project.

Fig. 2: Corrosion damage: prestressed hollow core panels at Level 1 walkway soffit (top left), balcony prestressed hollow core panel during construction demolition (top right), balcony cantilever beam (bottom left), and walkway beam (bottom right)

To determine an appropriate repair methodology, the design team reviewed the data, distress patterns, and general costs for various approaches. The complexity and time associated with intricate repairs on the thin section, hollow core panels was a key consideration. It was decided to remove and replace panels in areas with heightened observed distress and/or elevated chloride levels (ocean-side balcony panels and courtyard-side panels in the central portion of the condominiums) and implement limited repairs and a preventative protection strategy at remaining panels with a thermal spray CP system.

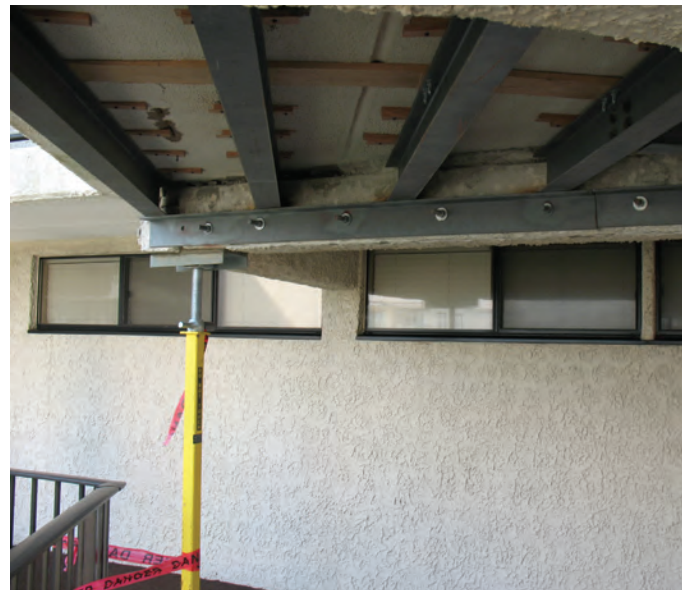
Fig. 3: Example of supplemental supports prior to project to make conditions temporarily safe

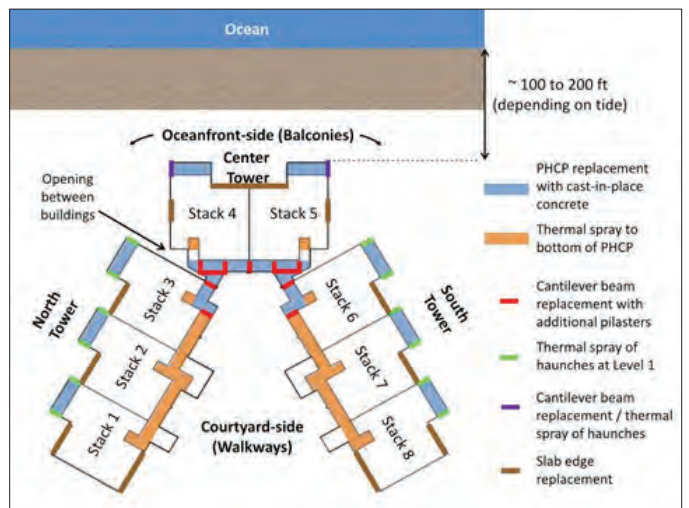
Fig. 4: Schematic plan view of buildings showing proximity to ocean and general repair methodology

Refer to Figure 4 for a schematic repair strategy. Costs associated with removal and replacement of cantilever beams with variable amounts of distress at walkway and balcony locations and slab edges supporting curtain walls on the ocean-side were also favorable compared to widespread implementation of individual concrete repairs and CP strategy at these areas. Ocean-side haunches were patched and galvanically protected with patch zinc anodes. Fenestrations were also replaced during the repair project and coatings were installed at vertical and horizontal components. The buildings were unoccupied during the renovation work. Work was primarily conducted between September and May of successive years (2009-2010, 2010-2011), with much of the concrete replacement and repair being conducted in the months of December through March.

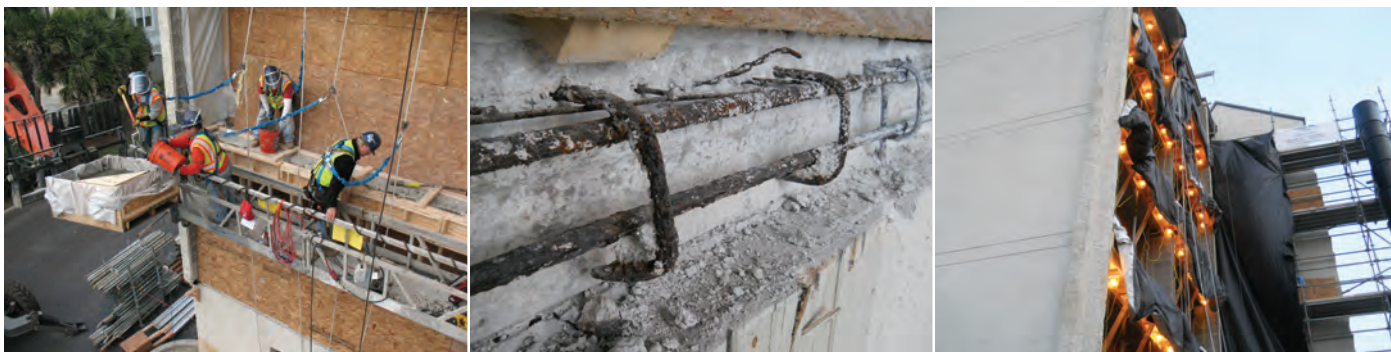
Fig. 5: Replacement of balcony slab edges from swing stage (left), example of corrosion of reinforcing steel during demolition (center), and example of thermal control (right)

Swing stages were utilized for slab edge replacement (Fig. 5). Slabs were demolished approximately 6 to 8 inches to remove contaminated concrete and provide clearance behind reinforcing steel bars for replacement. The variation in existing alignment in both horizontal and vertical planes required specific attention to placement tolerances. Surfaces were prepared using an abrasive sandblasting. Horizontal reinforcing steel bars were spliced or doweled into existing grout-filled masonry walls, as necessary. Existing reinforcing steel that served as anchors between the PHCP topping slab and slab edge were re-used when possible. Due to the condition, placement and limited amount of existing reinforcing, dowels were adhesively anchored into the hollow core sections at the end of the slabs. Tensile testing was conducted at representative anchors to verify anchor installation.

Pre-packaged repair materials were used in replacement. Draped protection and radiant heat from distanced lights were used to maintain the concrete at appropriate temperatures during cold weather. Coatings and new curtain walls were installed after the slab edges were placed and cured.

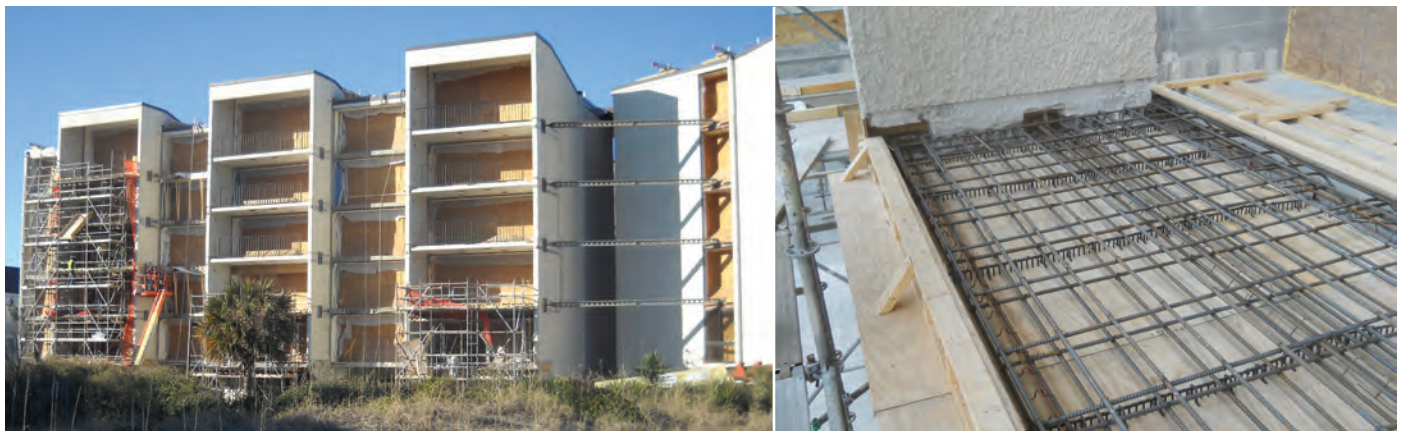
Fig. 6: Lateral bracing necessary for removing balcony slabs (left) and reinforcing layout at balcony (right). Note tabs at privacy wall used to support the new slab. Not easily visible in the figure is the tab nearest the threshold

At the balconies, existing PHCP slabs acted to laterally brace the structure; therefore, temporary braces were needed at each level prior to removal of the slabs to prevent out of plane buckling of the walls. Slabs were removed by demolition onto installed scaffolding below or removed by crane. Scaffolding was constructed full height to provide access for trade work. At balconies, three pockets 8 to 12 inches wide, 8 inches deep and the thickness of the slab were excavated into the wall on each side of the balcony that was approximately 7 feet wide. The tabs were reinforced to transfer loads from the slab to the load-bearing wall. A beam was formed at the sliding glass door to form the header and threshold for the door installation. Balcony slab removal and replacement was sequenced to reduce impact to project schedule. Figure 6 shows lateral bracing during construction and balcony slab reinforcement.

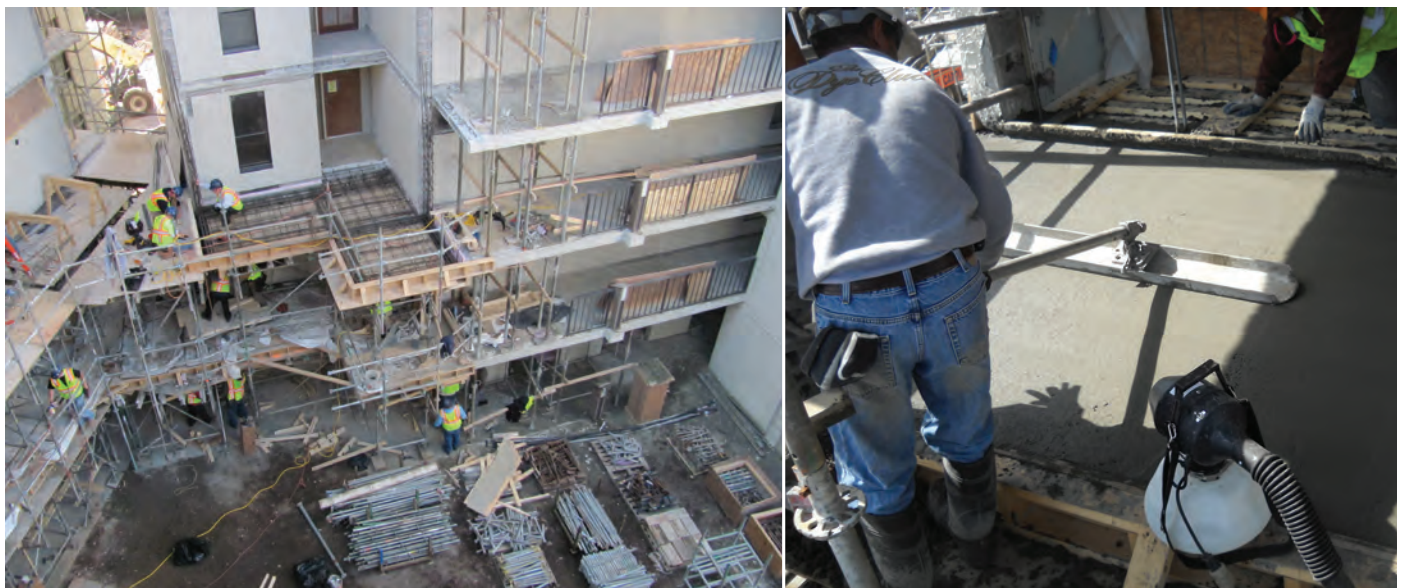
Fig. 8: Illustration of replacement of portion of walkway slabs (left) and balcony (right). Note the fogger at right of craftsman, used after finishing and prior to implementation of wet burlap and plastic for moist curing and insulating blankets when necessary

of compiled quality assurance data for strength and unit weight for all lightweight concrete used in beams, slabs and pilasters is provided in Figure 7. Slabs were fogged with an atomized fogger as necessary to resist plastic shrinkage cracking. Slabs were broom finished and immediately wet cured for a minimum of seven days. Heat and insulating blankets were used to maintain appropriate curing temperatures in cold weather. New exterior concrete masonry walls were installed on the concrete curbs and beams. Slabs were coated with a breathable cementitious coating after work was completed. Figure 8 shows general replacement operations at a typical central walkway area and balcony.

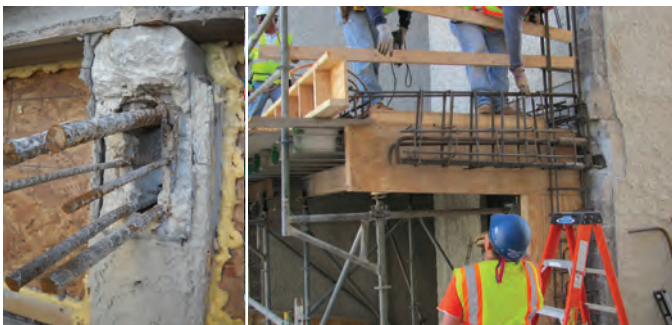
1. many of the cantilever beams had low or no cover to the steel from the reinforcing cages not being properly supported during the original construction,
2. top bars in the cantilevers were lower than appro-

appropriate and/or undersized for resisting code applied loads, and

Fig. 9: Walkway cantilever beam showing removed concrete, low cover to bottom of beam, excessive cover to top tension reinforcing steel, and voids (top left), partially formed reinforcing steel for reconstructed beams and pilasters used to reduce the stresses in the beam (top right), and completed pilasters and beams cast integrally with the new concrete slabs (bottom). The pilaster was tied to the wall. Note the mechanical splices used to tie to existing steel for this beam.

Beams were widened where necessary and deepened where possible to increase cover. Limited opportunity to deepen beams was available due to code required minimum overhead heights. Where possible, additional reinforcing was anchored to the existing portion of the beams above existing top reinforcing steel to increase capacity to meet current code load requirements. While this was acceptable in marginal situations, the use of pilasters tied to the masonry walls to reduce cantilever span was necessary in many cases on the walkway sides.

Hollow cells were grouted at pilasters to transfer load where grout was omitted during original construction. Galvanic point anodes were installed into a pocket of low-resistivity repair material attached to the existing portion of the cantilever beam to remain. Beams and pilasters were formed and placed concurrently with the slab systems. Figure 9 shows a removed walkway cantilever beam and reinforcing, partial forming of new beam and pilaster, and finished work after installation and coating application.

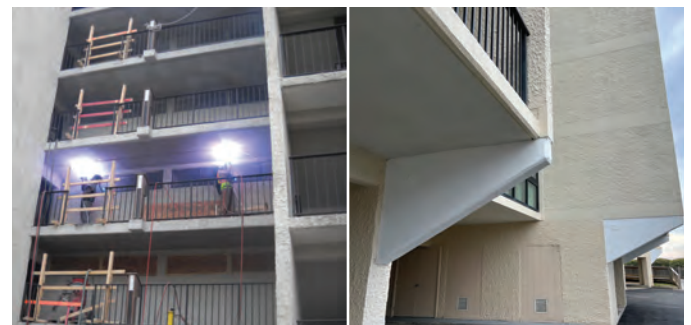
Fig. 10: Thermal spray being applied to the PHCP soffits (left) and current condition of haunches after thermal spray and coating application (right)

oms of PHCP on the walkway-side of the building in areas away from the building separations, where slabs were generally well protected, but exhibited variable levels of chlorides at the level of the steel. Specifications required a minimum of 12 mils thickness, or as required to provide a service-life extension of 15 to 20 years. Existing coatings were stripped from the panels. The panels were quite sensitive to coating removal and surfaces were rather rough in some places. Repairs at spot locations were completed. Excavations to the prestressing steel were made near the panel ends in a staggered fashion to make two connections per strand. An alloy of aluminum, zinc, and indium was applied to the surface by thermal spray and connected at the excavated sites by spraying into the excavations. Epoxy repair material was used to patch the excavations. A breathable coating was applied after the thermal spray was applied for aesthetics.

Haunches at Level 1 on the oceanfront-side were also protected with thermal spray galvanic protection. Steel plates were used as connections for thermal spray to reinforcing steel. A skim coat was applied in some places prior to installation, and a breathable coating was applied thereafter. Figure 10 shows thermal spray application at PHCP and current condition at haunches.

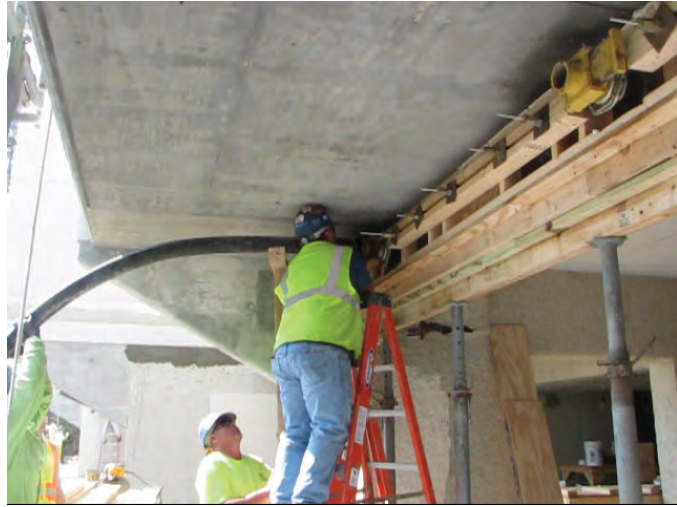
Fig. 12: Installation of self-consolidating concrete at a beam under a slab by pumping

Other repairs were implemented at the project. Self-consolidating concrete was used to replace deteriorated beams at level one with limited access (Fig. 12). The Contractor submitted a mixture design and installed plastic windows in the form to verify consolidation. Testing was conducted on-site to demonstrate flowability and stability. Other repairs included replacement of PHCP at the roof level, replacement of a deteriorated stair section and installation of prefabricated panels with incorporated galvanic CP on selected beams.

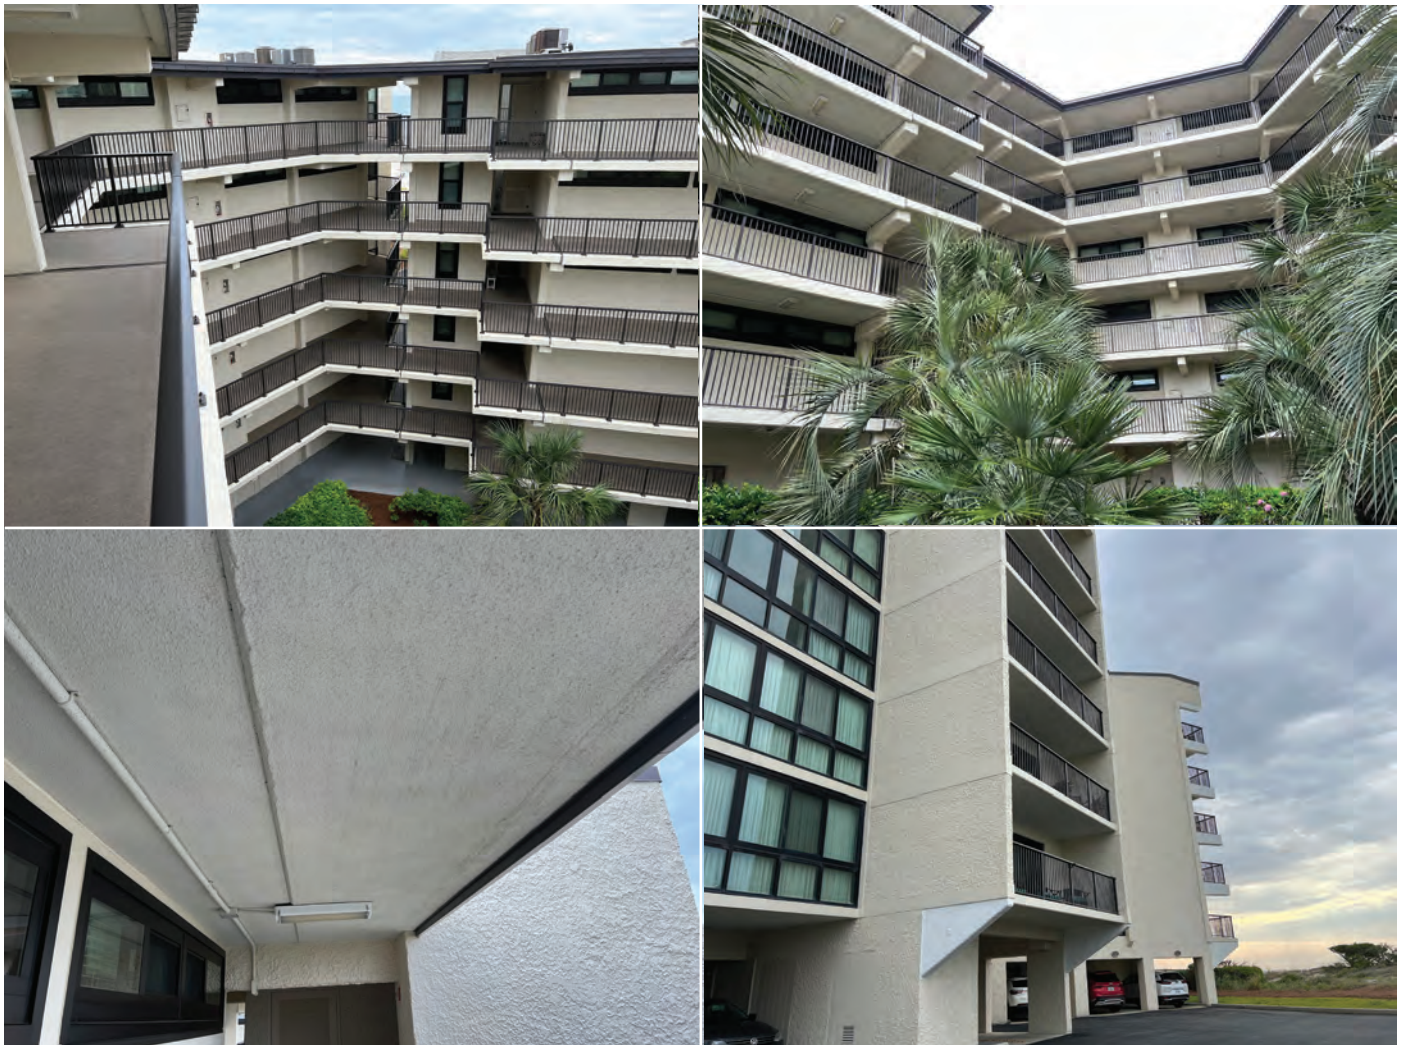
Both buildings were reviewed in 2017 and 2023, approximately 7 and 13 years after the primary repair project. New concrete balcony and walkway slabs and beams, as well as PHCP, beams and haunches subjected to cathodic protection, generally were performing well. Cathodic protection test systems were reviewed in 2017 and showed excellent protection to the instrumented hollow-core panel. Haunches and beams generally showed at least partial

Fig. 13: Examples of current conditions: walkways (top left and right), soffit with thermal spray and coatings (bottom left) and replaced balconies with thermally sprayed haunches (bottom right)

Approximately \$300,000 (3 to 4 percent of the primary project cost) in maintenance and repairs were completed in 2018 to address minor issues. Of this was about \$100,000 (approximately 1 percent of the primary repair project cost) for concrete and coating repairs / maintenance to address grinding some corrosion stains associated with tie wires on concrete surfaces, sealants, and concrete repairs. Concrete repairs were ascribed primarily to limited reinforcing steel that was inadvertently not connected into the cathodic protection system as well as minor stray steel. Other repairs included coatings on guardrails and typical sealant work. No significant corrosion-related damage to protected or newly installed components from 2008 was observed during a visual review in 2023. Example photos of the buildings as of 2023 are shown in Figure 13.
