# BUILDING ENVELOPE FAILURE

### CASE STUDY: SHIPYARD CONDOMINIUMS

Shipyards Village Buildings A and B are five story, forty unit beach front condominiums located in Pawleys Island, SC. Repairs totaling approximately \$8.5 million were undertaken at both buildings, including concrete repair and replacement, cathodic protection (CP), coatings and fenestration replacement. The structural system includes prestressed hollow-core panels (PHCP) supported by load bearing concrete masonry walls and reinforced concrete beams. Corrosion-related distress was observed at portions of the exterior PHCP and beams supporting the panels, and reinforced concrete slab edges supporting windows. A study was conducted to determine the contamination levels and distress of representative components with respect to the different areas of the building

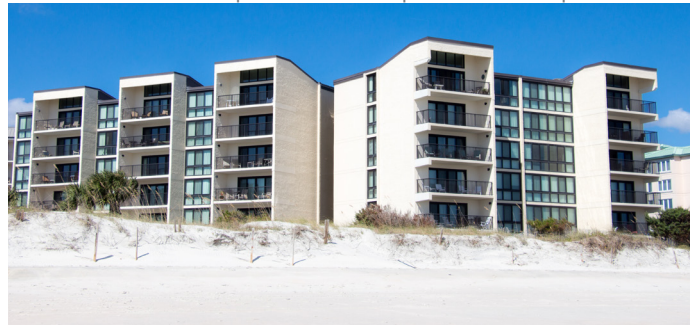
to select the economical repair methods. Corrosion of embedded reinforcing and prestressing steel was the result of elevated chloride levels in the concrete. Ocean-front slab edges were replaced with pre-packaged repair materials prior to new window installation. Land-side PHCP and ocean-side reinforced

concrete haunches supporting ocean-side masonry walls with minimal outward distress were protected with thermal spray CP and a breathable aesthetic topcoat. CP monitoring stations were installed at representative locations. Ocean-front PHCP and land-side PHCP with increased oceanic wind exposure, contamination and distress, and associated cantilever beams were removed and replaced with a high-performance lightweight concrete mixture. The mixture was designed with weight similar to the replaced PHCP, and resistance to chloride ingress, cracking and other deterioration mechanisms. New slabs were keyed into the existing masonry walls or supported on cantilever beams on the ocean-side balconies, depending on existing configuration. The land-side walkway sections were cast integrally with replaced cantilever beams without control joints. Because some existing beams did not meet current live load requirements, supplemental reinforcing or pilasters were installed to increase capacity. Cathodic prevention point anodes were installed at interfaces to deter incipient corrosion. Most concrete and repair work was conducted in winter, requiring close attention to placement and curing. Slabs were sloped to promote drainage and components were coated.
