CONCRETE REPAIR BULLETIN

July/August 2023
Vol. 36, No. 4

Design for Longevity: A Look Back at Concrete Rehabilitation and Preservation at Shipyard Village Condominiums

by David G. Tepke, Nicholas B. Tribble, and Stephen P. Robinson

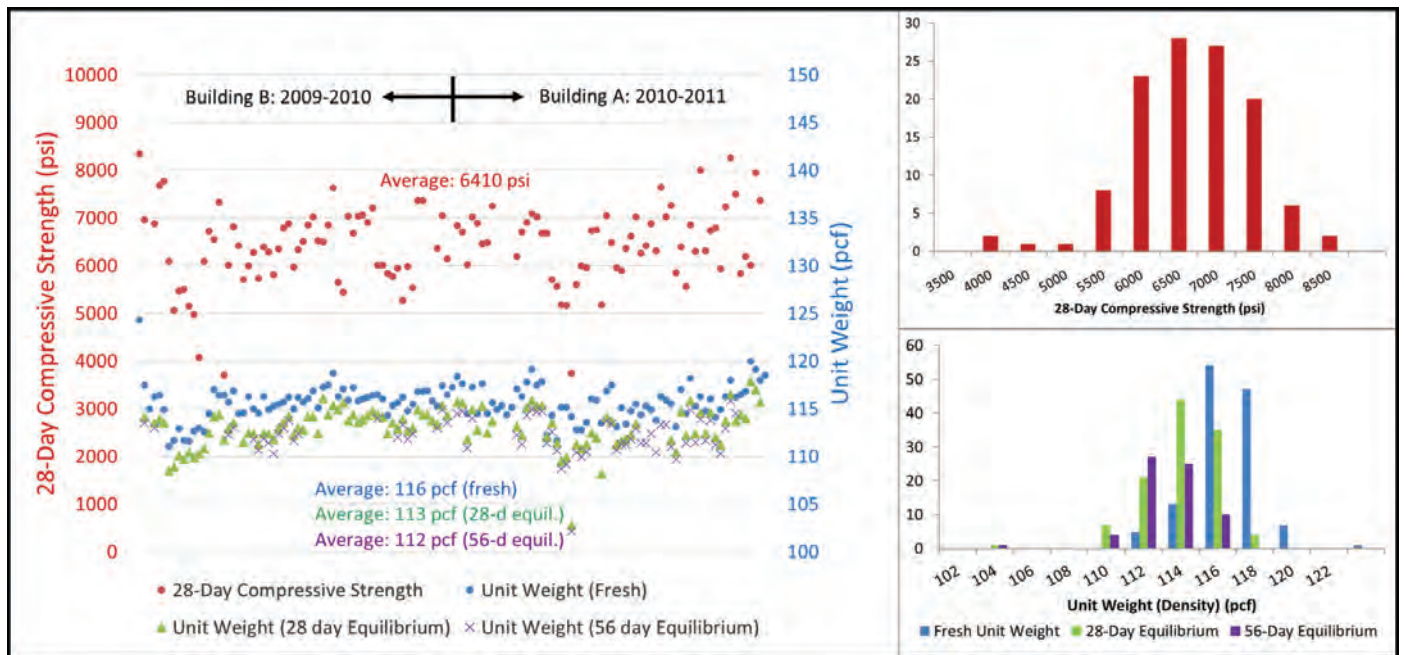
of compiled quality assurance data for strength and unit weight for all lightweight concrete used in beams, slabs and pilasters is provided in Figure 7. Slabs were fogged with an atomized fogger as necessary to resist plastic shrinkage cracking. Slabs were broom finished and immediately wet cured for a minimum of seven days. Heat and insulating blankets were used to maintain appropriate curing temperatures in cold weather. New exterior concrete masonry walls were installed on the concrete curbs and beams. Slabs were coated with a breathable cementitious coating after work was completed. Figure 8 shows general replacement operations at a typical central walkway area and balcony.

Fig. 7: Quality assurance data for 28-day compressive strength and unit weight (density) for batches of concrete delivered to site for both buildings

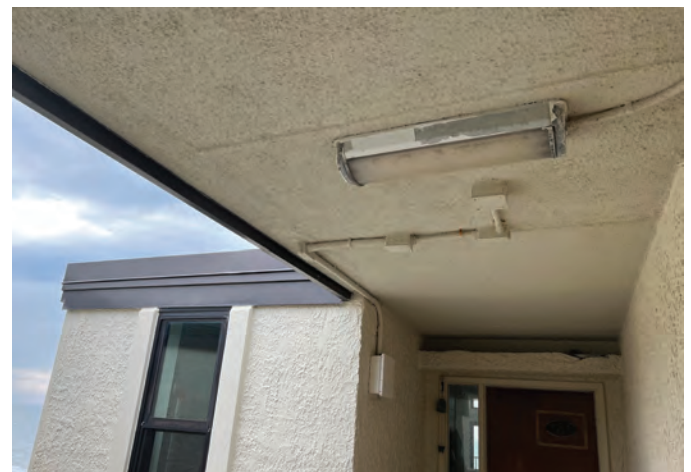
Fig. 11: Test station for CP testing at panel

monitoring stations to measure the effectiveness of the CP system during construction and in the future. These stations were installed on panels and haunches. Long-term monitoring equipment included embedded reference electrodes. Figure 11 shows a typical test station at a PHCP.
